# Manhole Inspection Summary

Manhole # S11YY\_016MH

Insp Date: **7/31/07 11:46 AM**

**Location** Address: **3513 HILTON RD** Cross Street: **BARRINGTON RD**

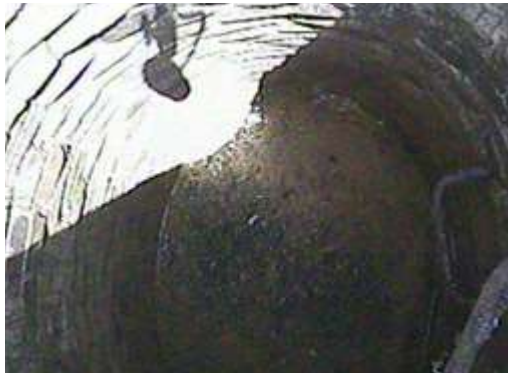
Top View

DEBRIS IN CHANNEL

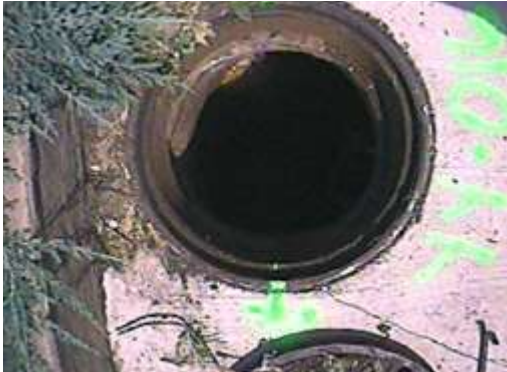
Top View

**Frame** Offset: **1** (in.) Condition: ☒ Sound ☐ Cracked ☐ Leaks

FRAME OFFSET

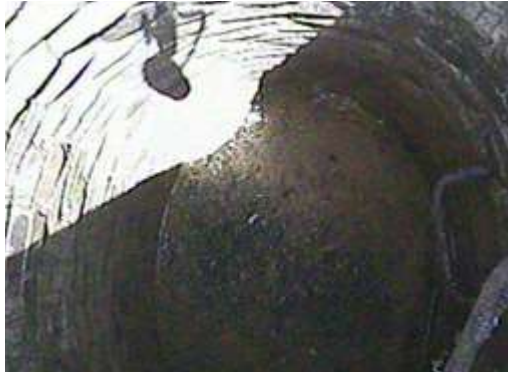
Defect 1

**Steps** Count: **3** Missing: **0** ☒ **Corroded**

CORRODED STEPS

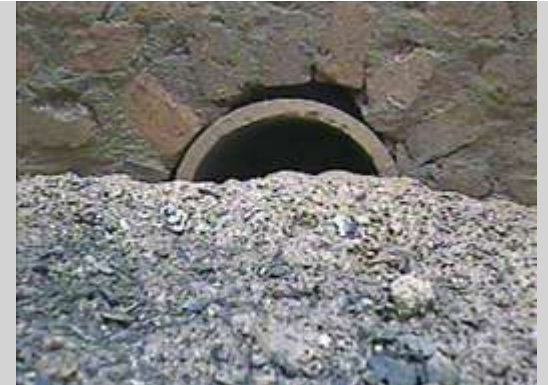
12 O'Clock Outflow

8 in. Circular Gravity Sewer  
Pipe Out @ 12 O'Clock

Deposits: ☐ None ☒ **Mud** ☒ **Sludge** ☒ **Debris** ☐ Grease

Silt Depth: **5** (in.) Deposits Extent: **Heavy**

Infiltration: **None** Pipe Seal Cond: **Cracked**

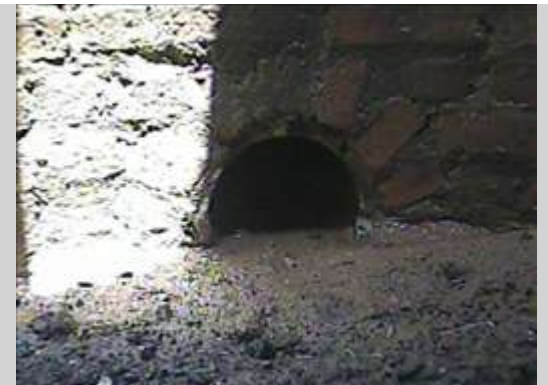
6 O'Clock Inflow

8 in. Circular Gravity Sewer  
Pipe In @ 6 O'Clock

Deposits: ☐ None ☒ **Mud** ☒ **Sludge** ☒ **Debris** ☐ Grease

Silt Depth: **3** (in.) Deposits Extent: **Heavy**
